# Edington's Grade II listed 18<sup>th</sup> Century Barn

*South West Heritage Local Heritage List grid ref; ST 38686 40050*

Cited as Hardings Barn on Edington's Village Design Statement but it is a Linhay 'unique in Somerset'. This is why.

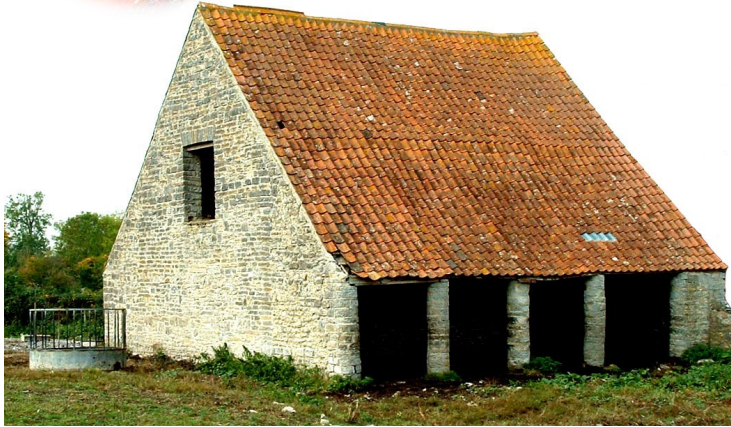
*Unattributed photograph of east face in 2000*

**Appearance and noteworthy features:** Coursed stone rubble with pan-tiled gambrel double-pitch (catslide) roof with deep eaves. Five bays; rectangular. The long east and west sides feature an open colonnade of rubble piers forming two open shelters. Behind each colonnade access to the barns hay loft is via paired plank doors with iron strap hinges. The doorways are set opposite each other. The west door features a cat hole. The hay loft features an open pitching 'window' on the south side. This building is an unaltered example of the local style of agricultural building in the mid 18th century. There are no stall divisions and there was no need for any means of tying the cattle. The shed provided shelter from the worst of the weather and a place in which cattle could be fed.

**Condition:** Poor and neglected (autumn 2023).

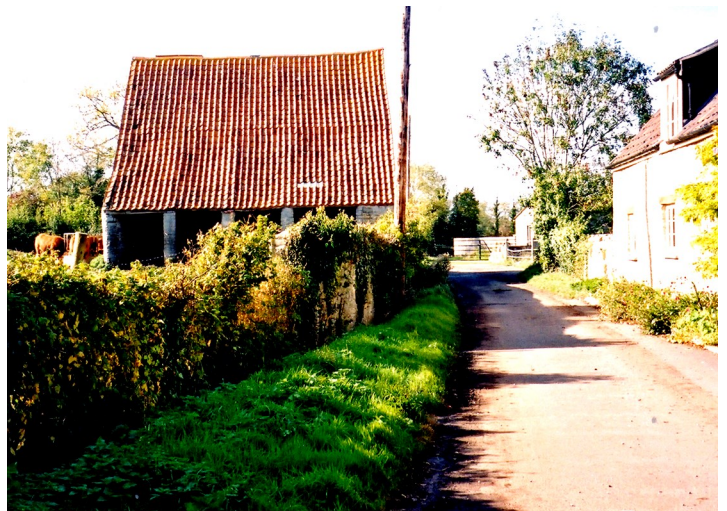
**Aim:** To conserve this linhay and thus help to facilitate life in a rural community. It features in *Somerset County Records Office 1839 Tithe Map for Edington*. (Photo © Robert Atkins 3 Oct 2003)
